INVENTORY OF MONUMENTS AT PAGAN

Volume One
Monuments 1-255

PIERRE PICHARD

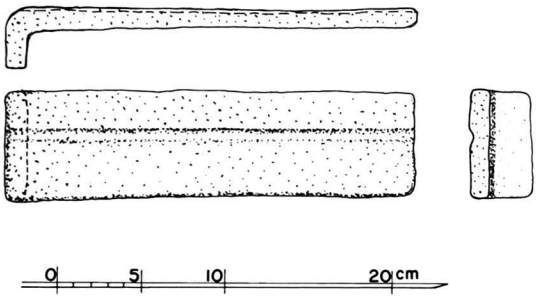
2306 a2 - Details of flat rectangular tile

remark
- the two fragments of roof-tile from the eastern timber pavilion provided a complete model: a flat, rectangular tile, 22 cm long, 10 cm wide, 15 mm thick, with hook and a longitudinal channel.

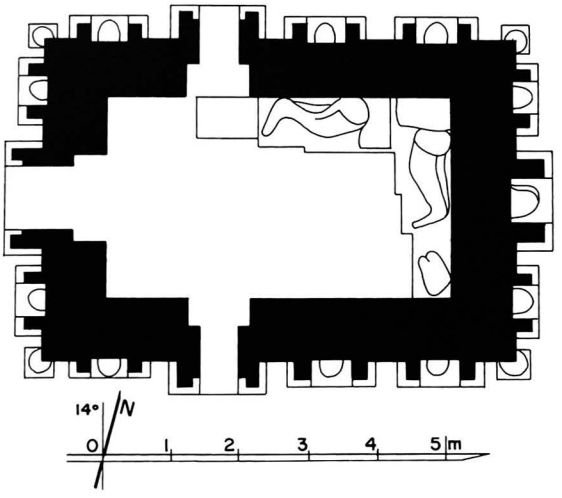
2410 a - Plan

5 present condition
- ruined.
- only base of walls remains.
- cleared of debris (Arch. Dept.) 1996.

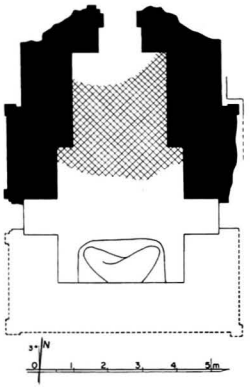
2416 a - Plan

5 present condition
- ruined.
- only parts of wall remains.
- vaults and upper parts collapsed.
- ground floor buried under debris.

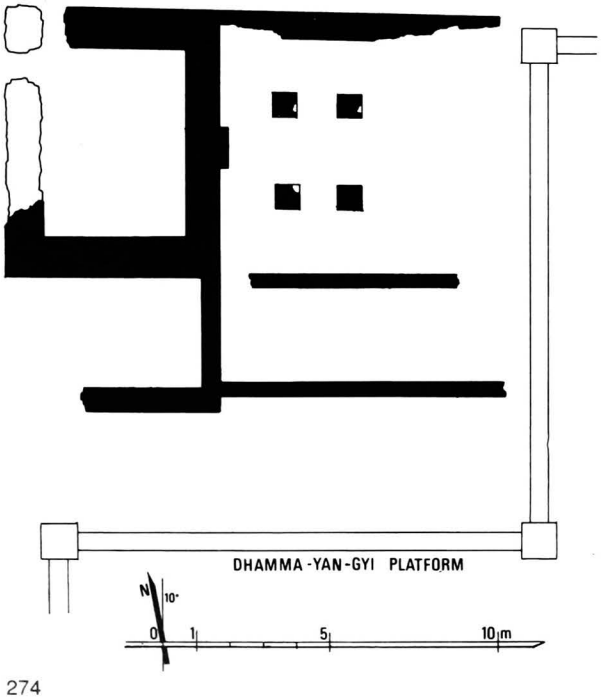
2459 a - Plan

5 present condition
- ruined.
- only base of walls and pillars remains.
- present height 0.90 m.
- cleared (Arch. Dept.) 1989.

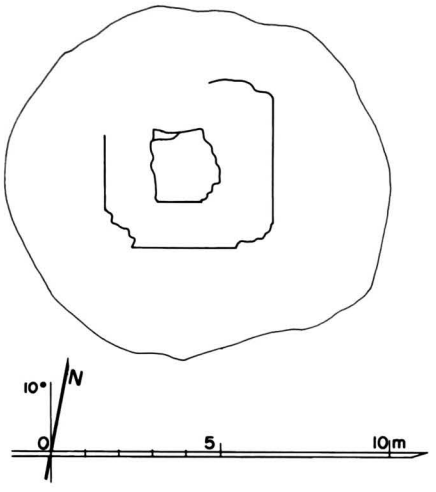
2549 a - Plan

5 present condition
- ruined and endangered.
- upper parts destroyed.

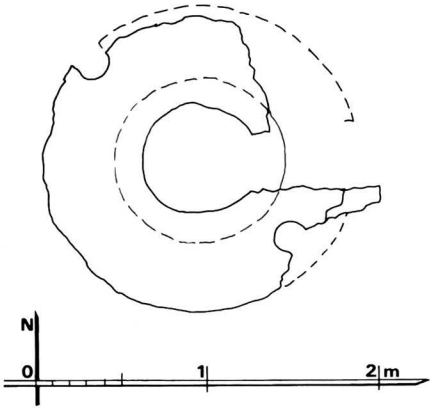
2601 a - Plan

5 present condition
- maintained and enclosed by a brick wall.

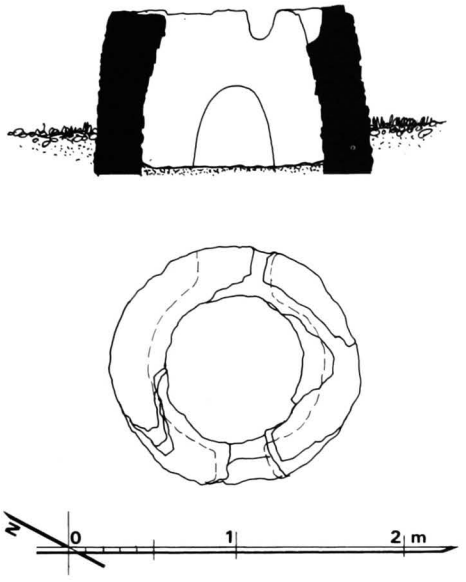
2602 a - Section and plan

5 present condition
- maintained and enclosed by a brick wall.

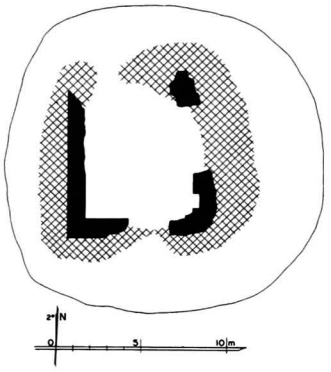
2617 a - Plan

5 present condition
- ruined.
- only base of walls remains.

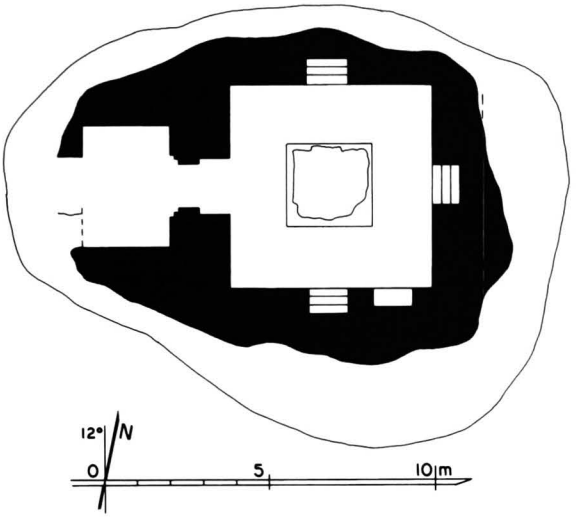
2638 a - Plan

5 present condition
- ruined.
- only base of walls remains.
- present height: 1.70 m.
- excavated (Arch. Dept.) 1930.

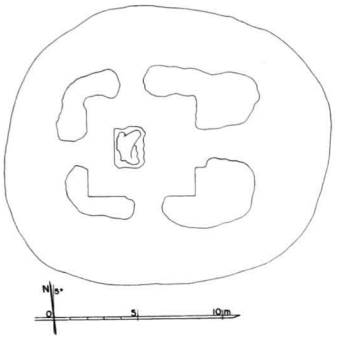
2644 a - Plan

5 present condition
- ruined.
- only base of walls remains.
- present height: 2.40 m.

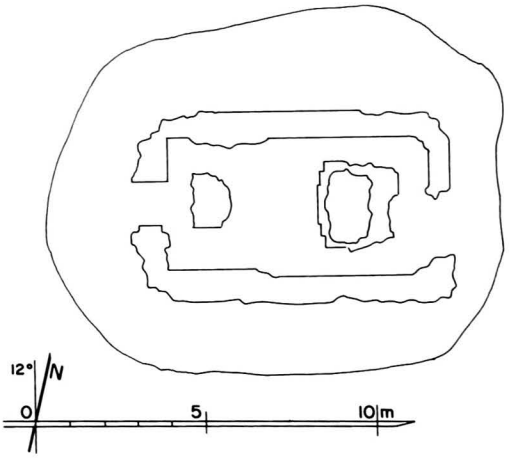
2647 a - Plan

5 present condition
- ruined.
- only base of walls remains.
- present height: 1.20 m.

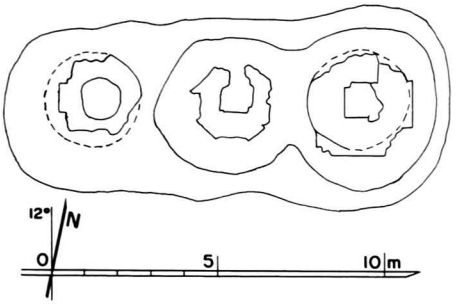
2657 a - Plan

5 present condition
- ruined.
- present height: 1.20 m.

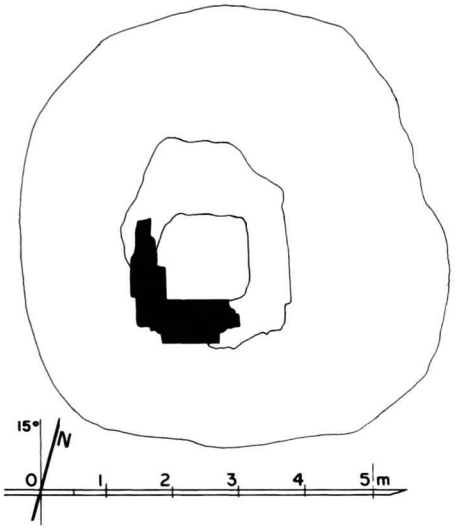
2659 a - Plan

5 present condition
- ruined.
- present height: 1.80 m.

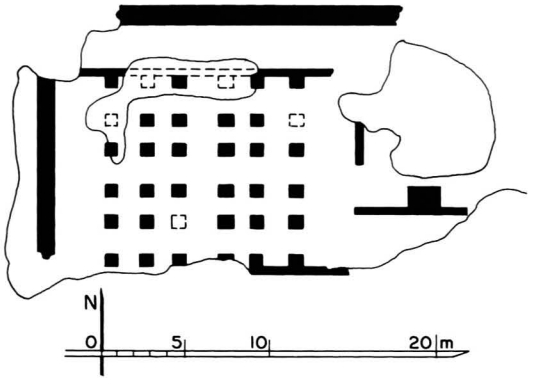
2662 a - Plan

5 present condition
- ruined.
- partially excavated.

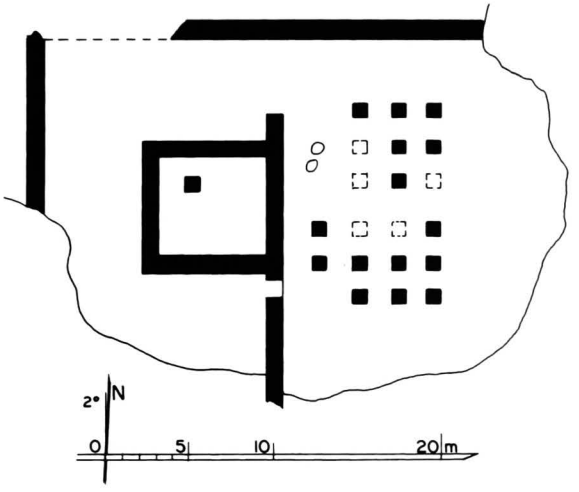
2663 a - Plan

5 present condition
- ruined.
- partially excavated.

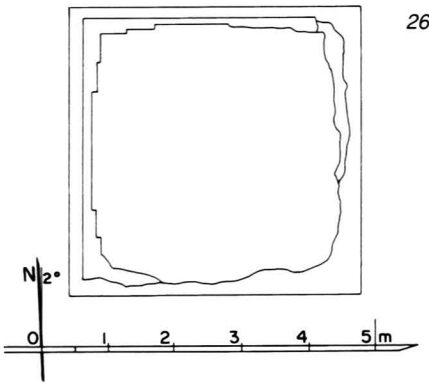
2687 a - Plan

5 present condition
- ruined.
- only base remains.
- present height: 2.50 m.

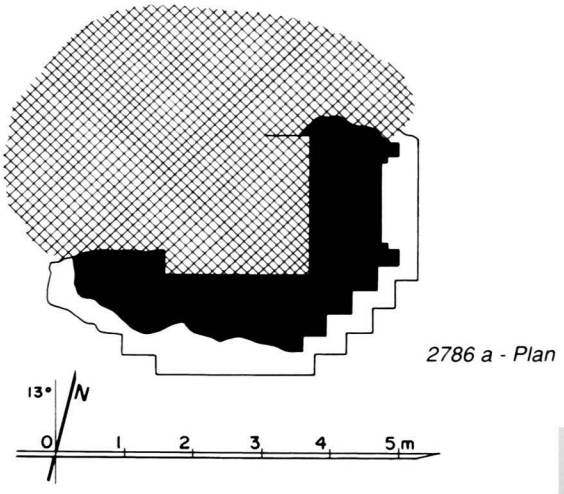
2786 a - Plan

5 present condition
- ruined.
- ground floor buried under debris.

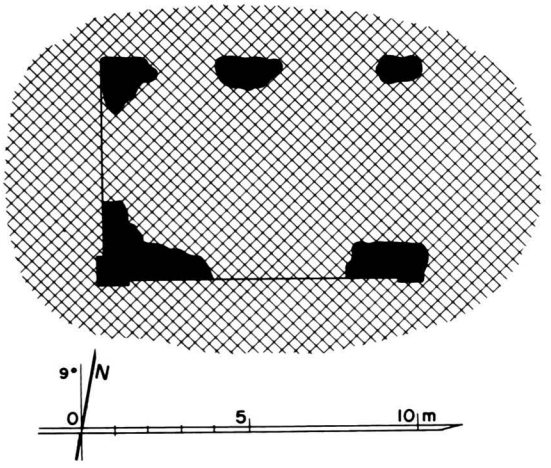
2797 a - Plan

5 present condition
- ruined.
- only base of walls remains.
- present height 2.50 m.
- ground floor buried under debris.

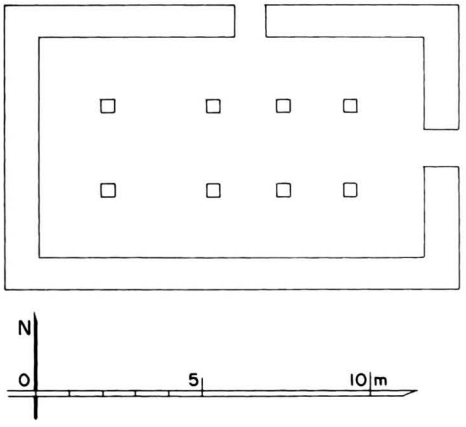
2814 a - Plan

5 present condition
- ruined.
- only base of walls remains.
- present height 1.10 m.
- cleared of debris 1996.

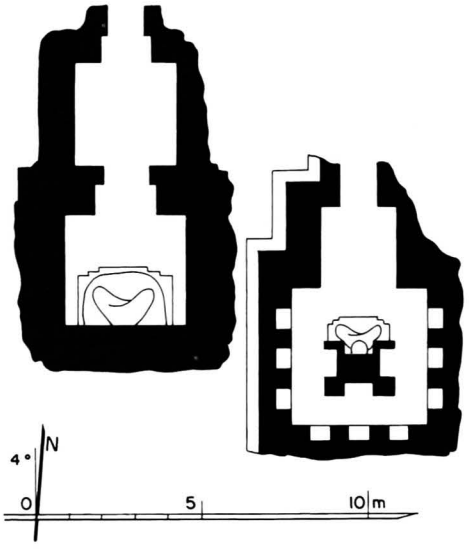
2830 a - Plan

5 present condition
- ruined.
- only base of walls remains.
- vaults and upper parts collapsed.
- present height 2.80 m.
- cleared of debris (Arch. Dept.) 1996.
